# IMPACT: A New Device for Thermo-Mechanical Investigation on Central Receiver Materials

**Abstract.** An innovative experimental tool for in-situ investigation of thermo-mechanical damage in solar receiver materials is designed and tested. The major benefit of this technique lies in the possibility for the operator to locate and follow the real-time damage evolution of the sample during solar radiation cycling, and to classify the observed mechanisms.

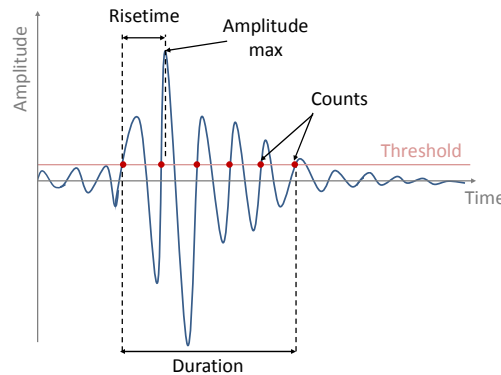
resultant waveform signal is called acoustic *hit*. Its principal characteristics are depicted on Figure 1: duration, amplitude, counts (recording threshold overrun), rise time (time to reach the maximum amplitude peak). They can be used to calculate other characteristics such as energy or frequency parameters.

**FIGURE 1.** Acoustic waveform characteristics.

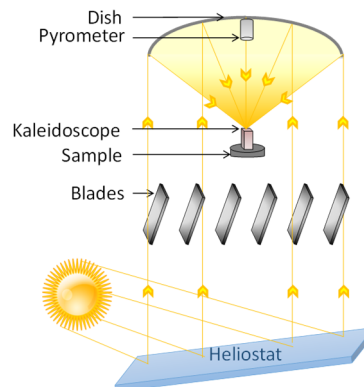
**FIGURE 2.** Solar facility – 2 m parabolic dish.

The solar irradiation is first collected by a flat heliostat, then reflected on a parabolic dish concentrating the solar flux onto the kaleidoscope entrance, and finally absorbed by the sample located at the kaleidoscope exit. The solar

flux is regulated by fast shutter blades, allowing a precise and repeatable control of the sample irradiation during the thermal cycles for most of the weather conditions. A solar-blind pyrometer is used to measure the front central temperature (measures start at 250°C).

The solar receiver irradiation conditions are reproduced on centimetre-sized samples by a 2 m-diameter parabolic solar furnace (Figure 2), located at PROMES-CNRS laboratory, Odeillo, France.

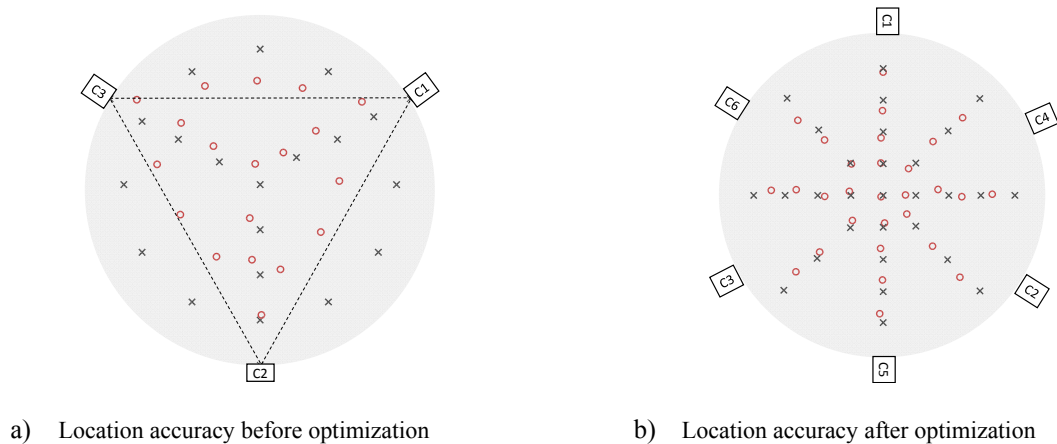
FIGURE 3. Improving the location reliability.

Results are presented in Figure 3 for two extreme cases: a) the basic configuration, with minimum number of sensors, low quality coupling and single location strategy; b) the optimized configuration, with a 6 sensors hexagonal array, high pressure coupling (0.67 N.mm<sup>-1</sup> spring), and combined location strategy. The grey circle stands for the sample, the sensors are drawn on its sides, and the acoustic simulation locations are reported: the references at the black crosses and the measurement at the red rings. The sensors array is delimited by the dotted line.

Acoustic simulations have been carried out in each possible configuration by breaking pencil leads (Hsu-Nielsen test, defined by the EN 1330-9 standard) on specific known locations on the sample disk, and comparing them to calculated ones based on the measurements. These sets of measures led to a 40% reduction of the mean position error, with a final value of 3.5 mm on a 100 mm diameter sample, which is less than 5% error.

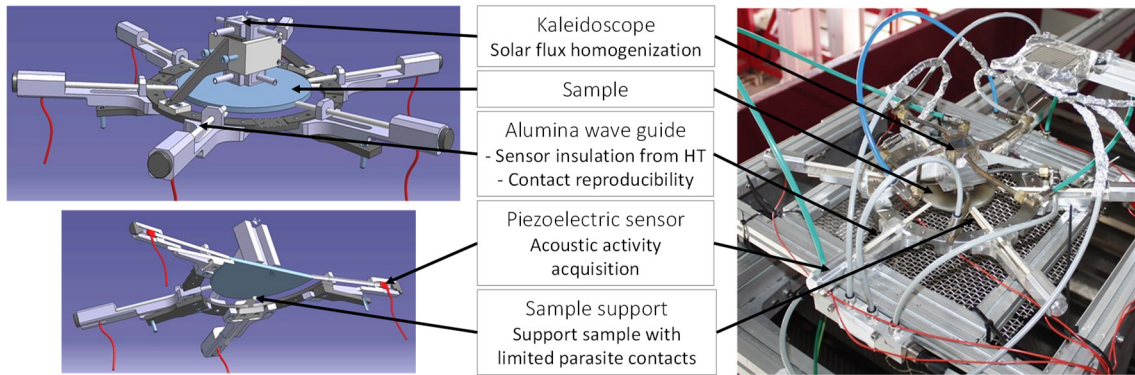
Considering the identified optimum experimental parameters, the IMPACT setup showed in Figure 4 has been designed (left part) and built (right part). The sample is supported by 3 alumina rods, and held by 6 rounded alumina waveguides. The tips of the waveguides are glued to the acoustic sensor using cyanoacrylate glue, and both are held

by a spring. Very thin K-type thermocouples are inserted between the sample and the three supporting rods: the sample pressure on the rods ensures a good mechanical contact with the thermocouples, and their small diameter avoids significant thermal disturbances.

FIGURE 4. Setup with improved location reliability.

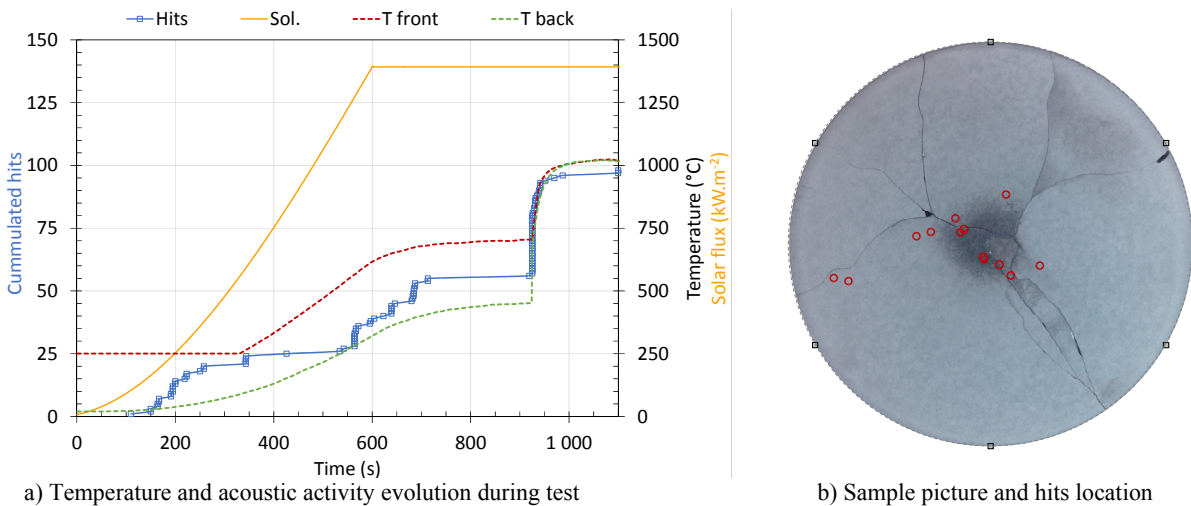
The thermal and acoustic behaviour of SiC during the test is depicted on Figure 5. On the graph Figure 5.a), the applied solar flux (yellow line), the measured front and back temperature (respectively red and green dotted line), and the cumulated acoustic hits (blue line with squares) are plotted as a function of time.

FIGURE 5. Test on a 100 mm diameter SiC sample: behaviour under exposure.

During this test, the SiC sample failed due to a cold point created by a kaleidoscope misplacement, creating a high stress level in a local zone. The time corresponding to the sample breakdown can be identified by the sudden

temperature rise (occurring at ~950s) which is associated with the rapid heating of the SiC piece remaining at the focus after the sample destruction. Figure 5.b) displays the located events and the crack pattern, from a failure initiated on the sample centre: the initial crack is supposed to be the one describe by the hits. An oxidation zone on the exposed part to the sun is visible.

The acoustic activity recorded before the sample failure reveals the setup ability to track the damage evolution before dramatic cracks. Only a part of the hits has been located as events, most probably due to discrepancy in coupling quality or to errors in wave velocity calculation. However, the located events clearly follow the crack pattern, demonstrating the ability of the setup to accurately locate events related to damage initiation and propagation.

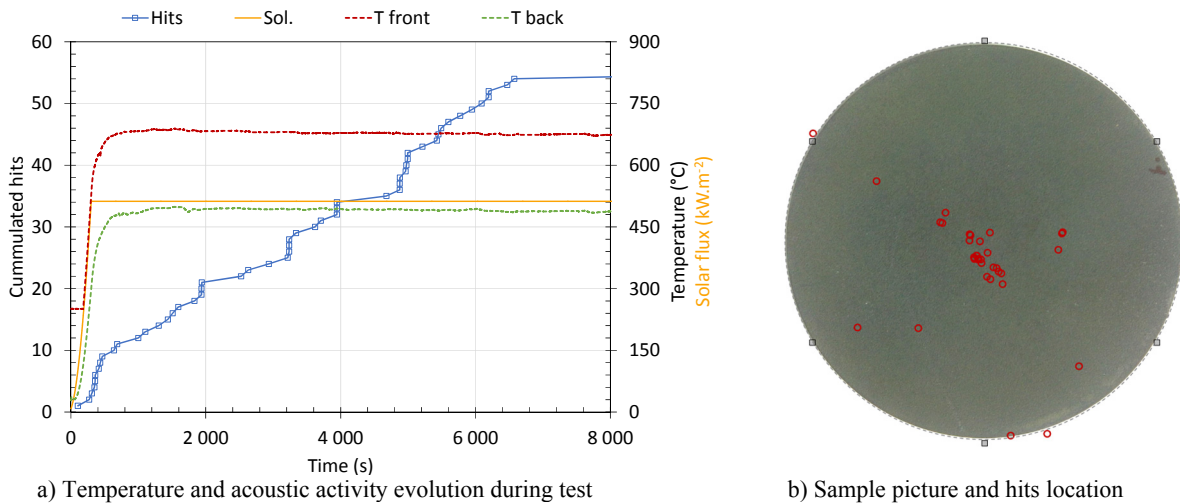
The thermal and acoustic behaviour of Inconel 625 during the test is depicted on Figure 6. On the graph Figure 6.a), the applied solar flux (yellow line), the measured front and back temperatures (respectively red and green dotted line), and the cumulated acoustic hits (blue line with squares) are plotted as a function of time. The cumulated number of hits increases regularly before 6400s, after what they stop to appear: that should correspond to a stabilization in sample microstructure face to the constant solar flux radiation. Figure 5.b) displays the located events, mainly found on the sample centre.

**FIGURE 6.** Test on a 100 mm diameter Inconel 625 sample: behaviour under exposure

The Inconel 625 acoustic activity is less profuse than the SiC one, but a slightly higher proportion of the hits has been located. Three of them are situated up to 1 mm outside the sample: that is obviously an error, but underlying the setup ability to locate events in the “dead-zone”.

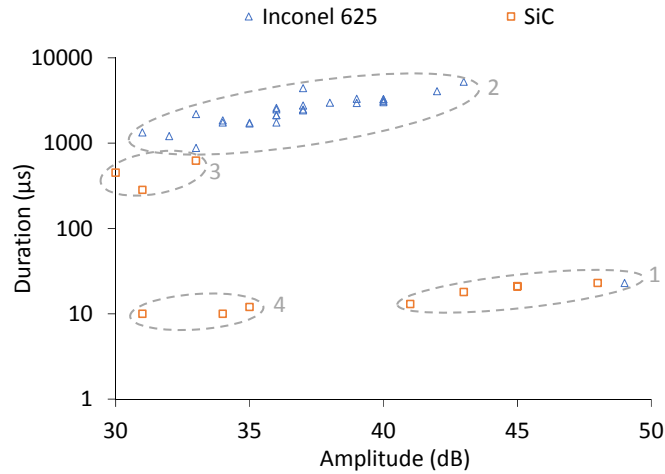
The category of the events generating the acoustic activity can be identified by scrutinizing the hits characteristics. When the hits amplitude of the located events in both samples are plotted as a function of their duration (Figure 7), different groups or clusters can be visually delimited. The Group 1 contains mainly hits from SiC (only one of Inconel 625), with high amplitude (between 40 and 50 dB) and low duration (20 μs on average): these characteristics generally describe a fissuring phenomenon [11]. Even if Inconel 625 sample did not show any crack, that could be micro-crack generated in the pre-existing oxide layer. The Group 2 contains exclusively hits from Inconel 625 sample, with a mean amplitude slightly lower (around 37 dB) and notably higher duration (2500 μs on average): these characteristics generally describe plasticity phenomenon [11]. The Group 3 contains exclusively hits from SiC, with regular amplitude and duration (lower than 34 dB and with a mean duration of 670 μs). These hits shows as well a low rise time (less than 200 μs), and then could be a crack propagation phenomenon [12]. The Group 4 also contains

exclusively hits from SiC, with low amplitude and duration (less than 36 dB and with a mean duration of 10  $\mu\text{s}$ ). Besides, their feeble absolute energy (around 1 aJ) suggests an oxidation phenomenon [13].

**FIGURE 7.** Duration vs Amplitude of recorded hits – SiC (orange squares) and Inconel 625 (blue triangles)
